KAPITEL 4 / CHAPTER 4⁴

CORROSION OF CONCRETE SEWAGE COLLECTOR ON THE EXAMPLE OF LVIV CITY

4.3. Gravity sewage collector in the city of Lviv on Akademika Sakharova Street

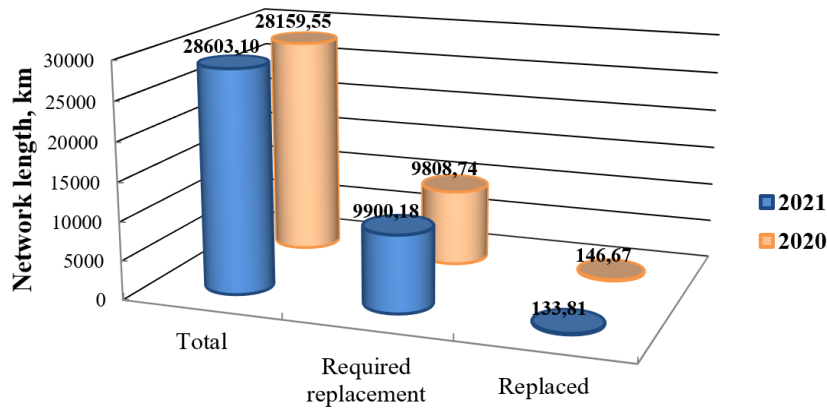
Figure 1 - Technical condition of the sewage networks in Ukraine

The main part of existing sewage networks in Ukraine was built more than 50 years ago. The total length of sewage networks was 28.603 thou. km in 2021, including failures – 9.9 thou. km or 34.6%. 0.133 thou. km or 1.4% of the need were replaced during 2021 (Fig. 1) [1].

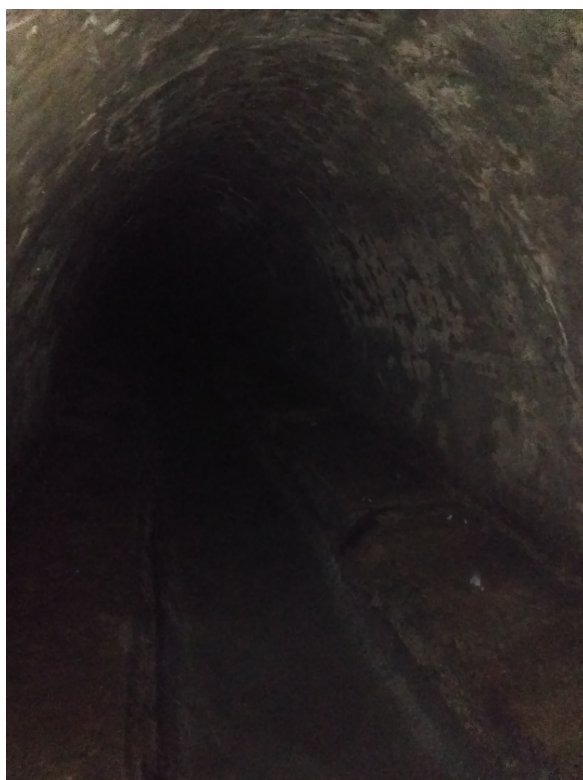
A visual inspection of the collector area (photo 1) indicates the development of the second stage of microbiological corrosion of its vault (photo 2). Silting of the tray part of the collector (photo 3) leads to its destruction..

Photo 1 – Sewage collector on Akademika Sakharova Street (Lviv)

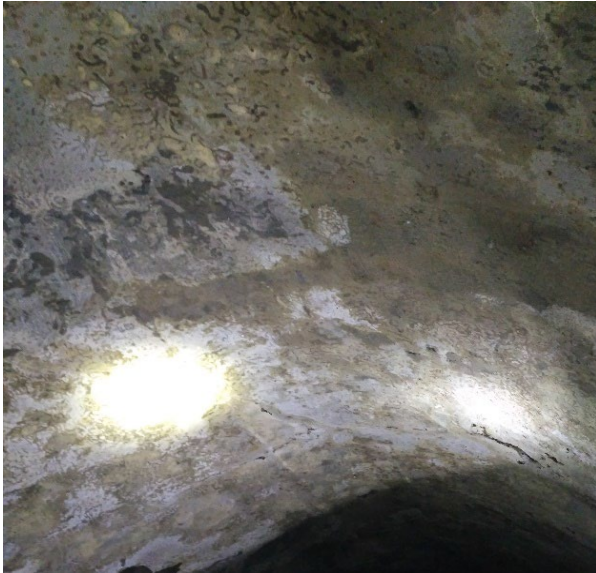
The presented materials describe the technical condition of sewage networks in Ukraine for 2021. The reasons for malfunctioning of sewage networks are outlined. The mechanism of concrete corrosion of sewage collectors is described. On the basis of a visual inspection of the gravity sewage collector of the city of Lviv, the development of the second stage of its microbiological corrosion was revealed.

Photo 2 – Vault of the sewer collector

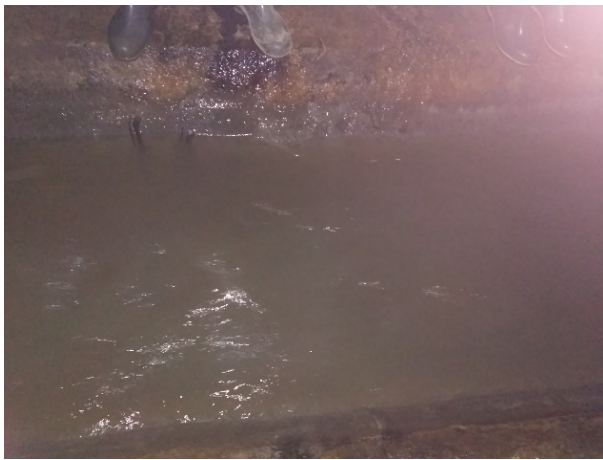
Photo 3 – Sewage collector tray
